Investigation of Internal Cracks in Epoxy-Alumina Using In Situ Mechanical Testing Coupled with Micro-CT

Polymer-ceramic composites are widely used in biomedical applications. This paper presents the results of an experimental investigation on the crack extension inside epoxy-alumina. Specimens with 5 vol.%, 10 vol.%, ..., 25 vol.% fillers fractions were fabricated. Three-point bending on single-edge notched bend specimens were performed using conventional mechanical tester and in situ mechanical tester coupled with micro-CT, respectively. Fracture toughness was measured to be 2.10–2.51 MPa√m, and it decreased with increasing filler fraction. When cracks were shorter than 0.88 mm, crack resistance for 5 and 25 vol.% epoxy-alumina was similar. Beyond 0.88 mm, 25 vol.% epoxy-alumina exhibited no crack resistance, whereas stress intensity factor kept increasing in 5 vol.% epoxy-alumina. The matrix-particle interfaces were the weakest link, where cracks often initiated from. Crack bridging by uncracked ligament and crack deflection were commonly observed toughening mechanisms. To design robust epoxy-alumina composites, increasing matrix-particle interface strength is recommended for f

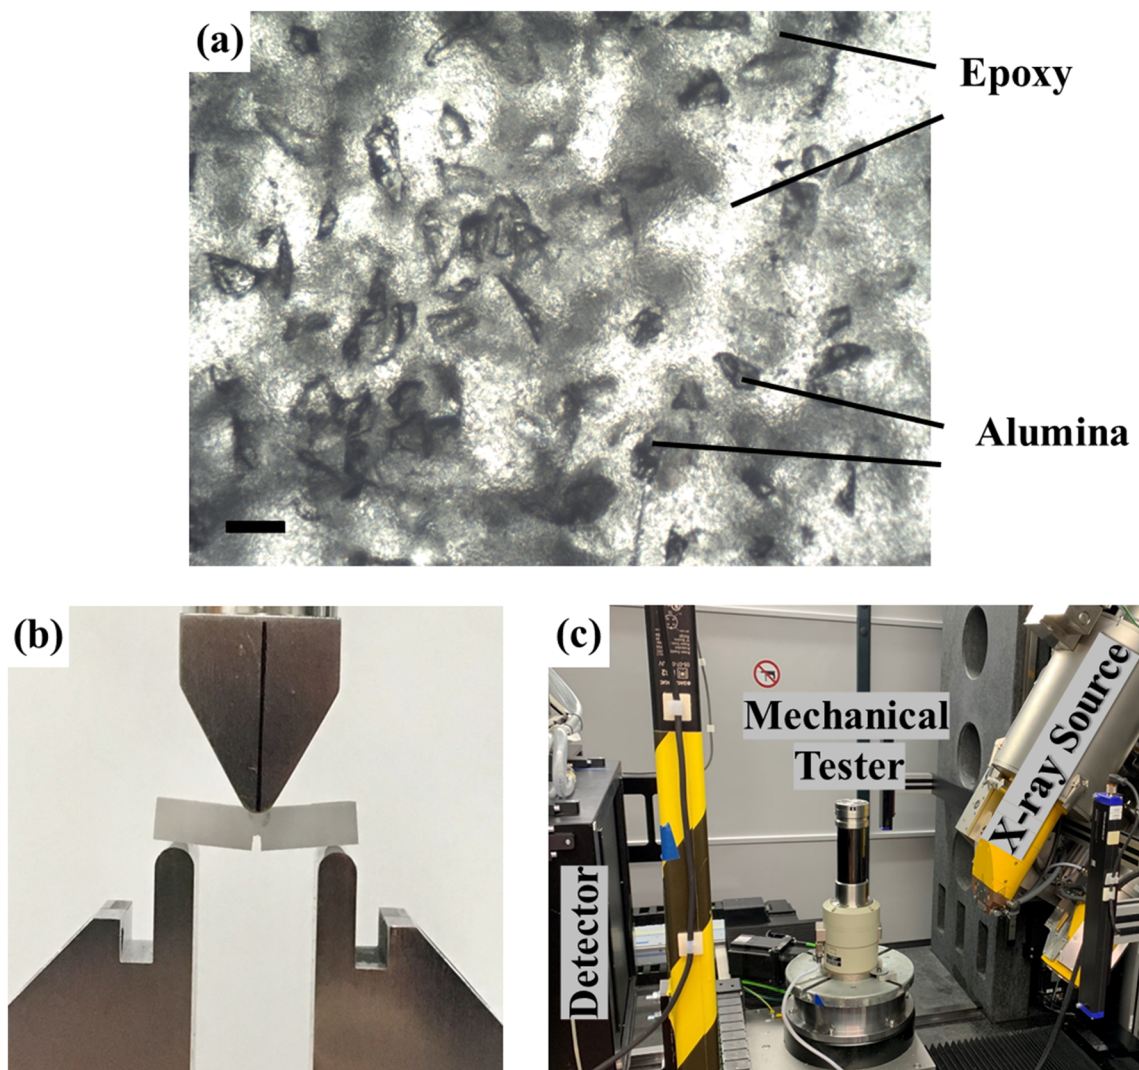
Fig 1. (a) Optical image of a thin slice of specimen (Scale bar 100 μm). (b) Experimental setup for 3-point bending test on epoxy-alumina SENB specimens using a conventional mechanical tester and (c) an in situ mechanical tester coupled with micro-CT.

Three-point bending tests were performed on the epoxy-alumina specimens using a mechanical testing machine (Electro E3000, Instron, Norwood, MA) with a loading span of 20 mm (Fig. 1b). They were conducted in air at room temperature. Four to five specimens were tested for each volume fraction of the epoxy-alumina specimens and for pure epoxy specimens, respectively. They were loaded monotonically to failure under displacement control at a cross-head speed of 0.1 mm/min . The loads and displacements were recorded by the tester.

Incremental three-point bending tests were performed on one 5 vol.% and one 25 vol.% epoxy-alumina specimens using a loading device (CT5000, Deben, Suffolk, UK) coupled with micro-CT (Phoenix v|tome|x L300, GE, Boston, MA) (Fig. 1c). The specimen geometry, loading span and the displacement rate were the same as previously described in “Three-Point Bend Using Conventional Mechanical Tester” section. 0.1 mm/min is the lowest displacement rate in the loading device coupled with micro-CT.

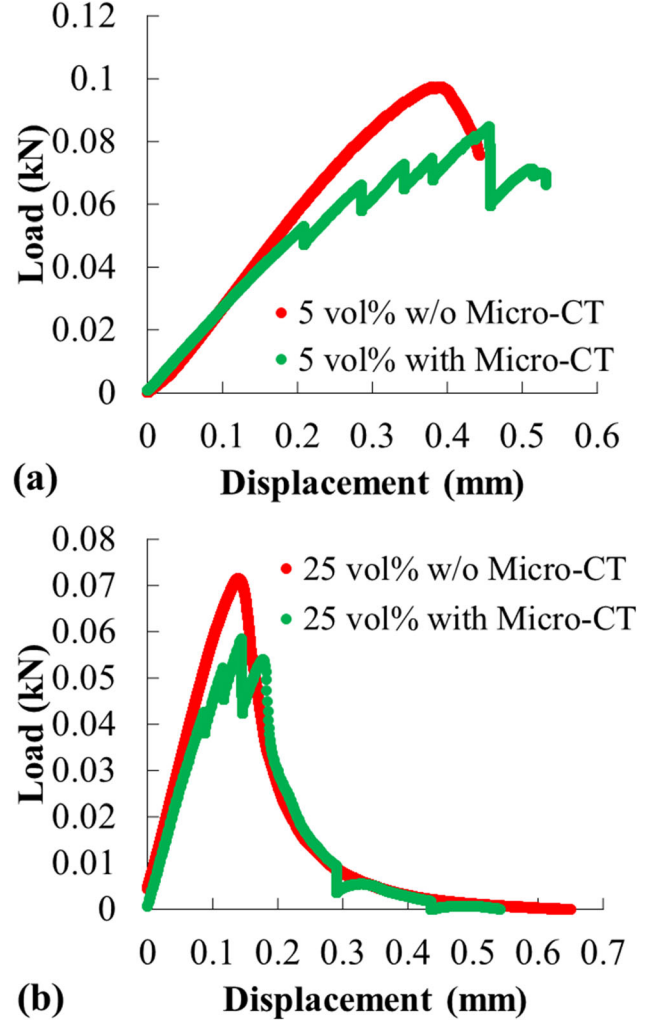
Fig 3. Comparison of load-displacement curves obtained from 3-point bending test in a conventional mechanical tester and in an in situ mechanical tester coupled with micro-CT: (a) 5 vol.% and (b) 25 vol.% epoxy-alumina SENB specimens.

The load-displacement curves recorded during the incremental three-point bending tests coupled with micro-CT are presented in Fig. 3. They are compared with the load-displacement curves recorded in the tests using conventional tester (Fig. 3). The initial loading portions of the curves with and without coupling with micro-CT were overlapping. When the tests were paused, the loading frame was held still and the applied load on the specimen reduced during stress relaxation. Hence the load recorded in the tests coupled with micro-CT was

lower than that in the conventional tests (Fig. 3). When the tests went past the maximum load, the load-displacement curves with and without coupling with micro-CT overlapped again, especially for the 25 vol.% epoxy-alumina specimen.

Although the same displacement rate was used in the 3-point bending tests without and with micro-CT scans, the time length deferred in the two types of testing, due to the holding and micro-CT scans in the tests coupled with micro-CT. This could contribute to the differences in the load-displacement curves (Fig. 3). The effects of loading rate need to be explored in future works.

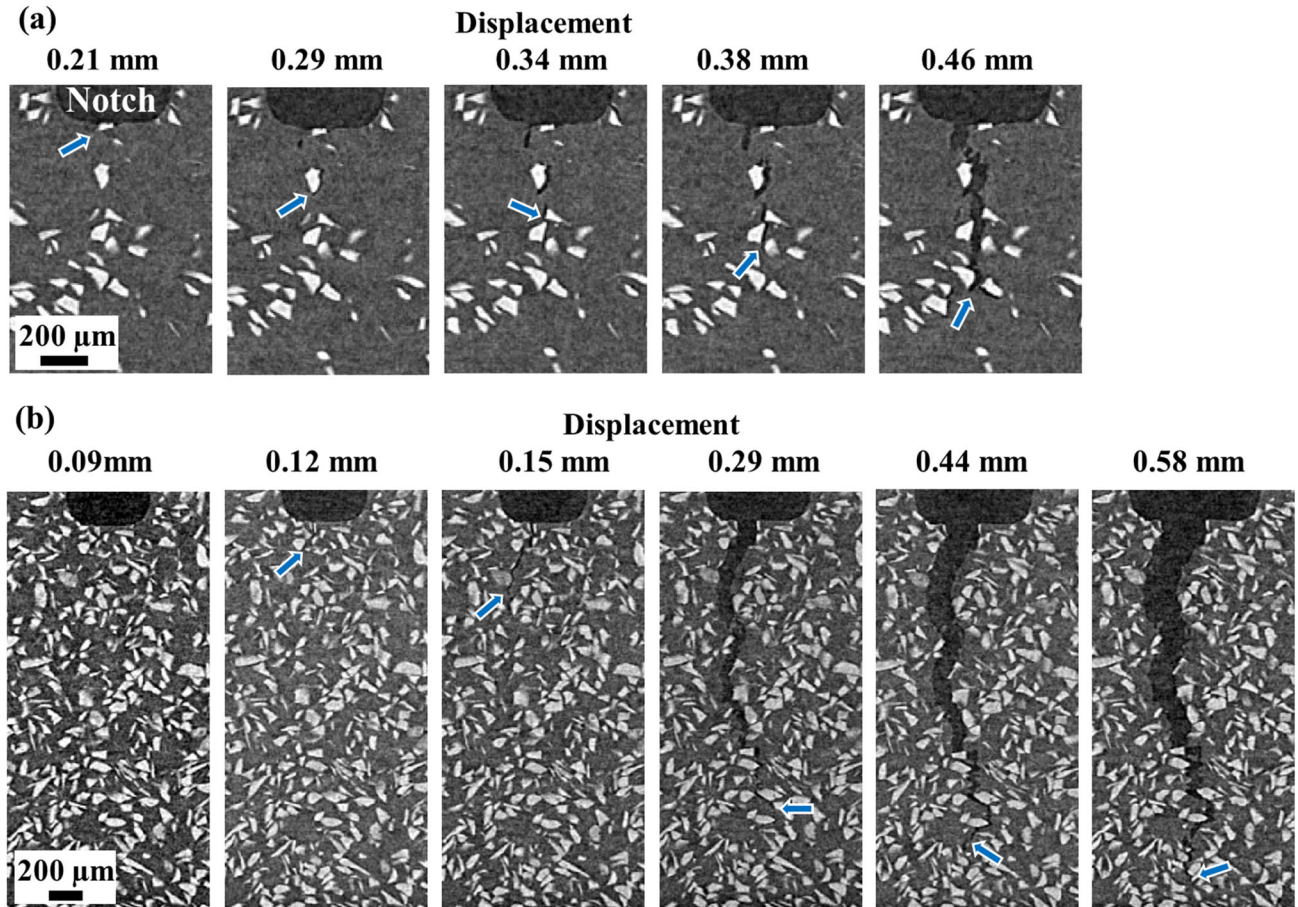
Fig 4. Micro-CT image slices showing the crack growth in (a) 5 vol.% and (b) 25 vol.% epoxy-alumina SENB specimens at different stages during 3-point bending test. Arrows are pointing at the crack tips.

Micro-CT images taken during the incremental three-point bending tests coupled with micro-CT are presented in Fig. 4. The 5 vol.% specimen was scanned five times when the displacement was 0.21, 0.29, 0.34, 0.38, and 0.46 mm, respectively. It then fractured when the displacement reached 0.53 mm (Fig. 3a). The 25 vol.% specimen was scanned six times when the displacement was 0.09, 0.12, 0.15, 0.29, 0.44 and 0.58 mm, respectively (Fig. 3b). At 0.58 mm displacement, the load dropped to about zero, but the specimen did not fully fracture. These are consistent with observations in the conventional

Micro-CT image slices at the same locations inside the specimens at each incremental step are compared (Fig. 4). During the test, multiple cracks developed from the notch and propagated into the specimens. The crack length, Δa , from the notch to the tip of the longest crack inside the specimens (arrows in Fig. 4) were measured from the image slices to be 0.14 mm, 0.31 mm, 0.58 mm, 0.76 mm and 1.04 mm for 5 vol.% epoxy-alumina and 0 mm, 0.29 mm, 0.88 mm, 1.94 mm and 2.20 mm for 25 vol.% epoxy-alumina, respectively.

The 2D micro-CT image slices also show several toughening mechanisms for epoxy-alumina composites. Crack deflection was a commonly observed toughening mechanism. It can be seen in Figs. 4b and 7b. Crack bridging by uncracked ligament was also common (Figs. 4a and 7c). Crack bridging by the filler particles can be seen in Fig. 7d, but it was not commonly observed. Additionally, the 3D volume rendered images (Fig. 6) demonstrated toughening by micro-cracks.

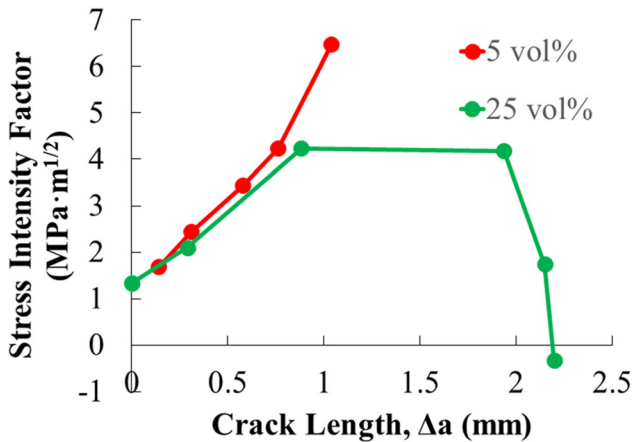
Fig 5. Crack-resistance curves for epoxy-alumina composites.

The crack growth resistance curves (R-curves) for the 5 vol.% and 25 vol.% epoxy-alumina composites are given in Fig 5. The results show that the two composites had similar crack-initiation toughness around $1.33 \text{ MPa}\sqrt{\text{m}}$. The crack resistance capabilities for the two composites were also similar, when the cracks were shorter than 0.88 mm. When the crack length was greater than 0.88 mm, the 25 vol.% epoxy-alumina exhibited no crack resistance, with the stress intensity factor first remained constant and then decreased with crack extension. In contrast, stress intensity factor kept increasing in 5 vol.% epoxy-alumina and the slope of the R-curves

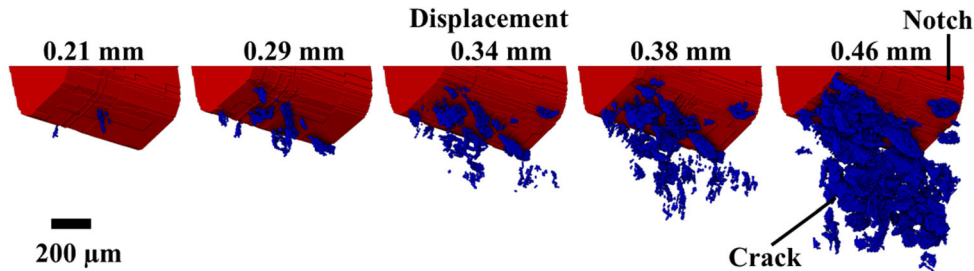
Fig 6. 3D volume rendered micro-CT images for a 5 vol.% epoxy-alumina SENB specimen at different stages during 3-point bending test. Red—notch; blue—cracks. The specimen was rendered fully transparent for better presentation of the cracks.

3D volume rendered images revealed the 3-dimensional development of cracks inside the materials (Fig. 6). To better visualize the cracks, only a section of the specimens near the longest crack was presented. The images (Fig. 6) show that multiple one-dimensional (1D) needle-shape cracks initiated from the notch (0.21 mm displacement); while extending into the materials, they also extended in the thickness direction of the specimen and became 2D plate shape (0.29 mm displacement); multiple cracks extended at the same time while new cracks initiated from the notch (0.34 mm displacement); these cracks had different lengths and the longest crack can be considered as the main crack (0.38 mm displacement); crack coalescences can be observed at the final stages of damage (0.46 mm displacement).

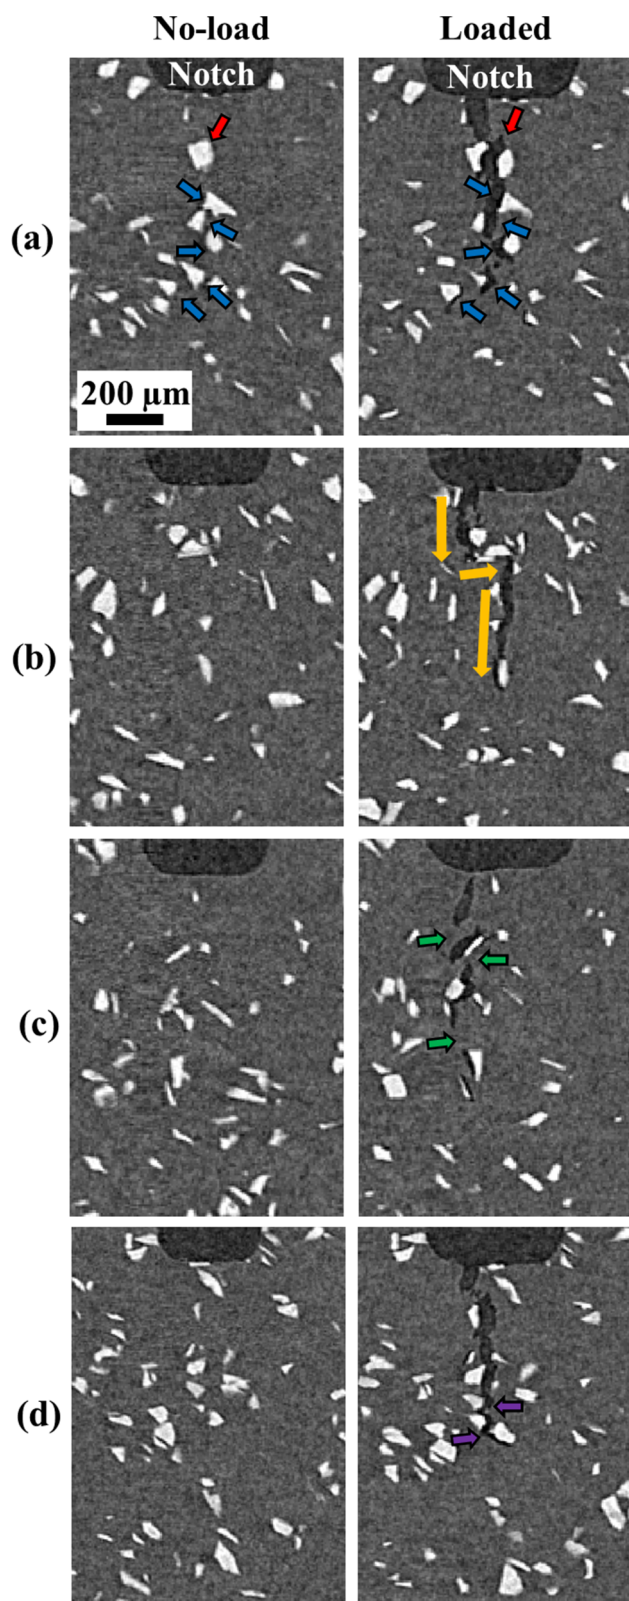
Fig 7. Comparison of micro-CT images of 5 vol.% epoxy-alumina taken at no-loaded and loaded conditions showing (a) the crack growth paths through the matrix, across the particles (red arrow) and at the matrix-particle interfaces (blue arrows), (b) crack deflection toughening, (c) crack bridging by uncracked ligament and (d) crack bridging by the fillers (Color figure online).

The 2D micro-CT image slices show the typical crack paths inside the materials (Fig. 7a). Cracks propagated through the epoxy matrix, through the alumina particles, and also along the particle-matrix interfaces. Cracks going through the alumina particles and causing particle fracture were observed less frequently than other cases.
